June 25, 2025

Project #9820

Testing Weathermaster Ultimate MP and Titegrab Plus on Evolution Steel Deck Frame and Outdoor Tile (Fortress Building Products)

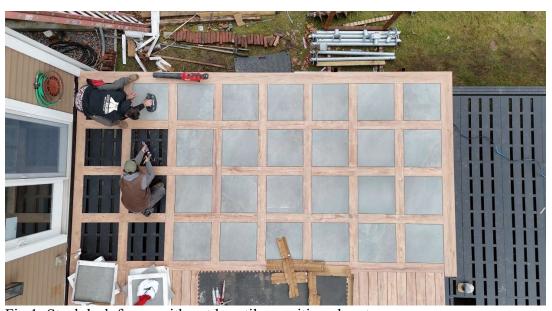
Fig 1: Steel deck frame with outdoor tiles positioned on top.

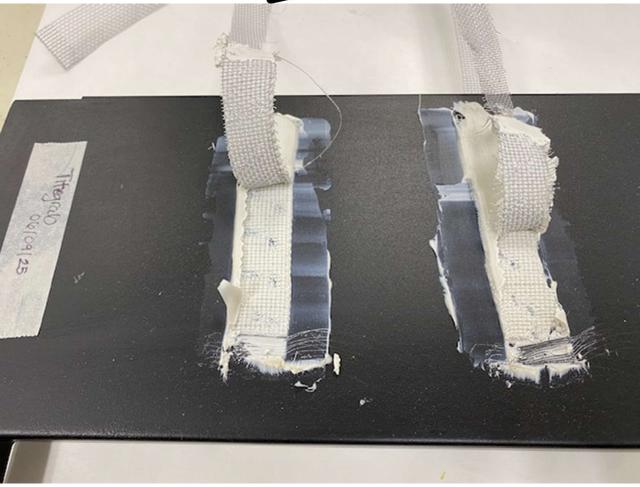
Fig 3. Post test: Picture showing cohesive failure for Titegrab on steel deck frame. Good adhesion to the frame.

Weathermaster Ultimate MP	Titegrab Plus
Evolution Steel Frame	16.615	15.988
Outdoor Tile	17.047	14.829

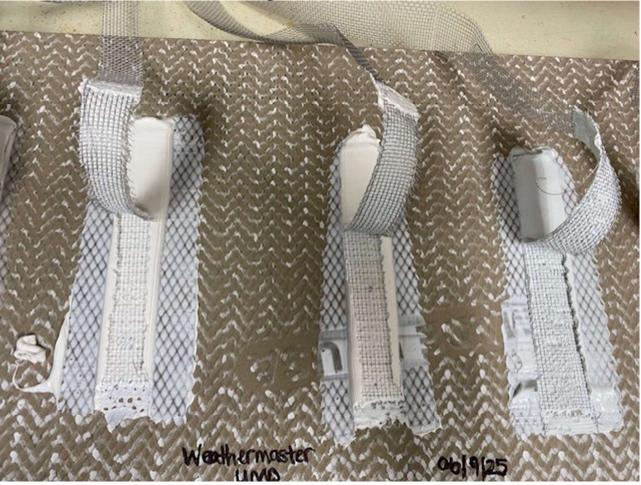
Fig 4. Post test: Picture showing cohesive failure for Weathermaster on outdoor tile. Good adhesion to the outdoor tile.

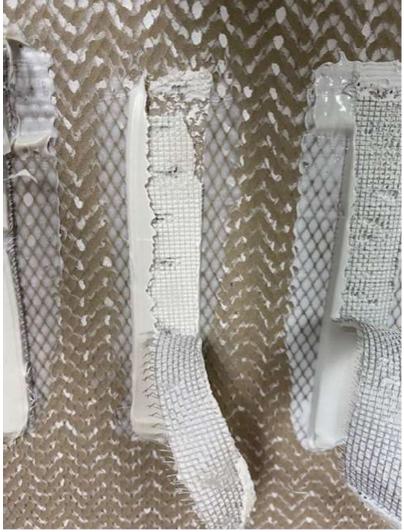
Fig 5. Post test: Picture showing cohesive failure for Titegrab on outdoor tile. Good adhesion to the outdoor tile.
